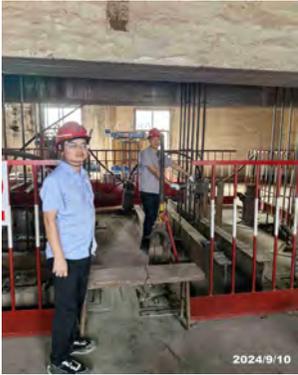
128	GX-B1598/24-2-24187	2024. 9. 23	实测钢丝绳有效截面积损失百分比最大为1.66%，小于5%为正常。

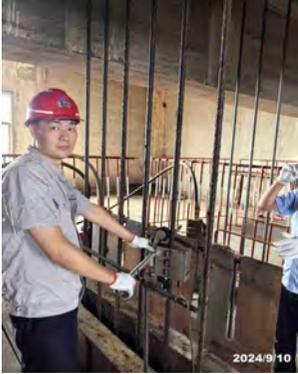
129	GX-B1598/24-2-24188	2024. 9. 23	实测钢丝绳有效截面积损失百分比最大为1.51%， 小于5%为正常。

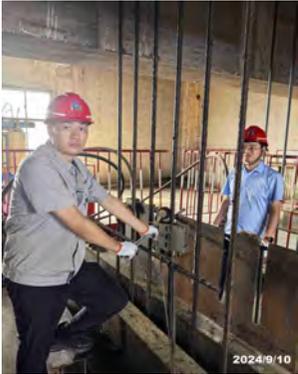
130	GX-B1598/24-2-24189	2024. 9. 23	实测钢丝绳有效截面积损失百分比最大为1.72%， 小于5%为正常。

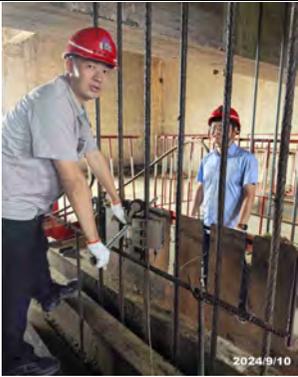
131	GX-B1598/24-2-24190	2024. 9. 23	实测钢丝绳有效截面积损失百分比最大为1.64%， 小于5%为正常。

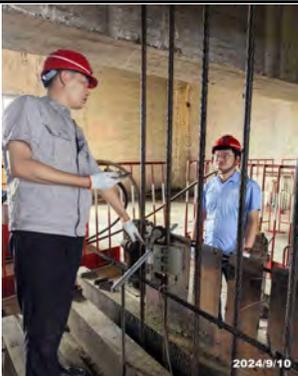
132	GX-B1598/24-2-24191	2024. 9. 23	实测钢丝绳有效截面积损失百分比最大为1.53%， 小于5%为正常。

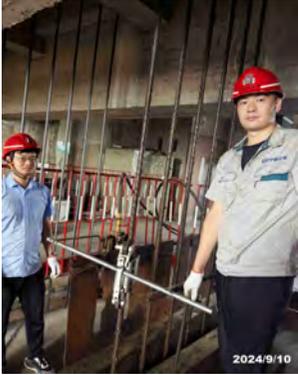
133	GX-B1598/24-2-24192	2024. 9. 23	实测钢丝绳有效截面积损失百分比最大为1.38%， 小于5%为正常。

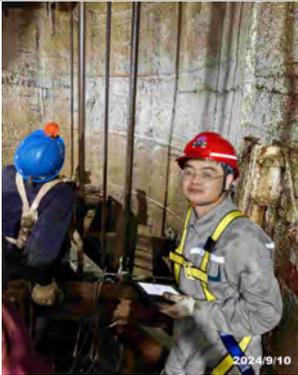
134	GX-B1598/24-2-24193	2024. 9. 23	实测钢丝绳有效截面积损失百分比最大为0.95%， 小于5%为正常。

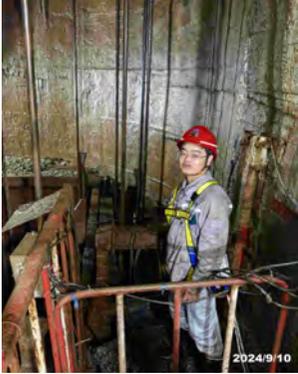
135	GX-B1598/24-2-24194	2024. 9. 23	实测钢丝绳有效截面积损失百分比最大为0.78%， 小于5%为正常。

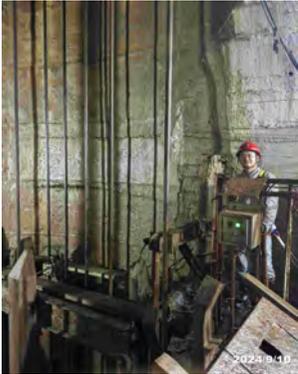
136	GX-B1598/24-2-24195	2024. 9. 23	实测钢丝绳有效截面积损失百分比最大为1.59%， 小于5%为正常。

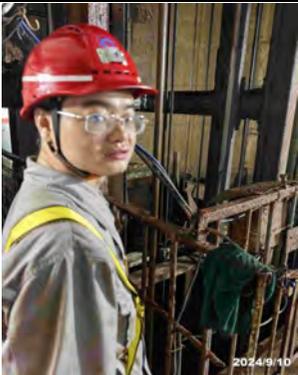
137	GX-B1598/24-2-24196	2024. 9. 23	实测钢丝绳有效截面积损失百分比最大为3.62%， 小于5%为正常。

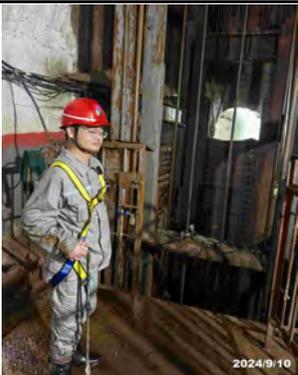
A photograph of a worker wearing a red hard hat, safety glasses, and a grey safety harness. The worker is positioned on a wooden structure, possibly a scaffolding or part of a machine, in an industrial setting. A date stamp '2024/9/10' is visible in the bottom right corner of the image.
138	GX-B1598/24-2-24197	2024. 9. 23	实测钢丝绳有效截面积损失百分比最大为3.48%， 小于5%为正常。

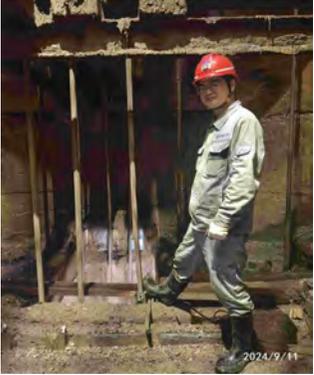
139	GX-B1598/24-2-24198	2024. 9. 23	实测钢丝绳有效截面积损失百分比最大为3.37%， 小于5%为正常。

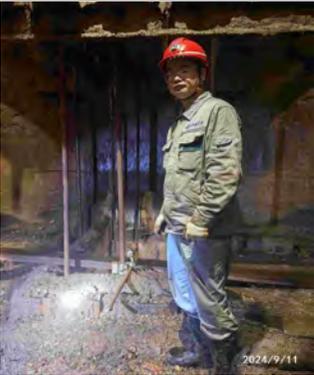
140	GX-B1598/24-2-24199	2024. 9. 23	实测钢丝绳有效截面积损失百分比最大为2.66%， 小于5%为正常。

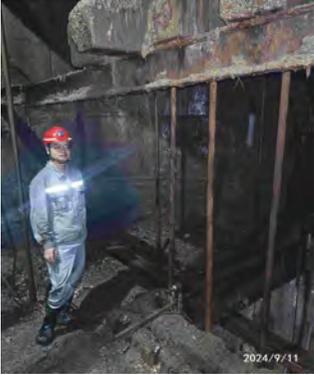
141	GX-B1598/24-2-24200	2024. 9. 23	实测钢丝绳有效截面积损失百分比最大为3.20%， 小于5%为正常。

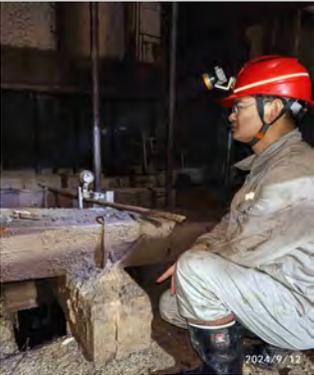
142	GX-B1598/24-2-24201	2024. 9. 23	实测钢丝绳有效截面积损失百分比最大为2.83%， 小于5%为正常。

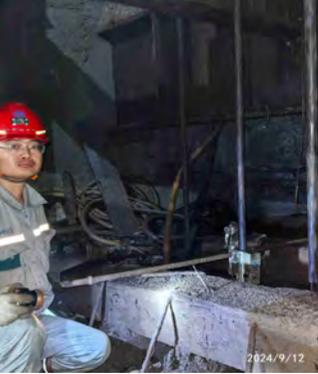
143	GX-B1598/24-2-24202	2024. 9. 23	实测钢丝绳有效截面积损失百分比最大为2.91%， 小于5%为正常。

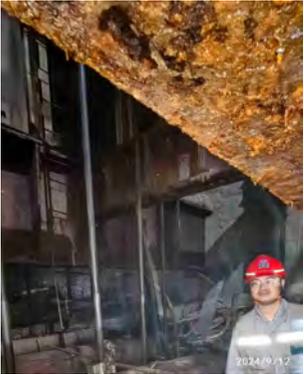
144	GX-B1598/24-2-24203	2024. 9. 23	实测钢丝绳有效截面积损失百分比最大为2.60%， 小于5%为正常。

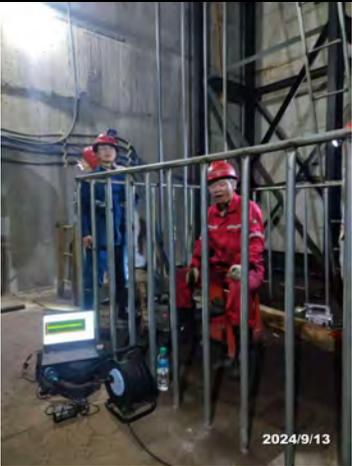
151	GX-B1598/24-2-24204	2024. 9. 25	实测钢丝绳有效截面积 损失百分比最大为 1.78%，小于5%为正常 。

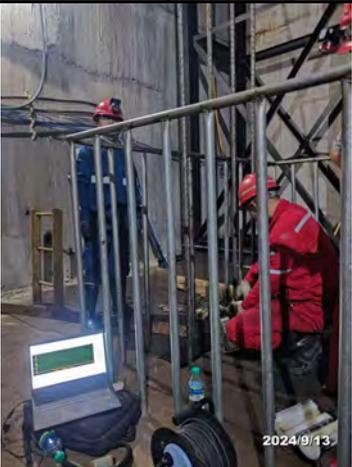
152	GX-B1598/24-2-24205	2024. 9. 25	实测钢丝绳有效截面积 损失百分比最大为 1.63%，小于5%为正常 。

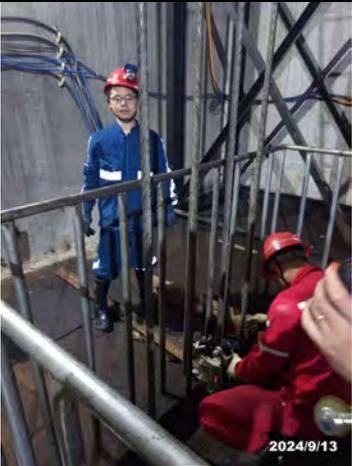
153	GX-B1598/24-2-24206	2024. 9. 25	实测钢丝绳有效截面积 损失百分比最大为 1.35%，小于5%为正常 。

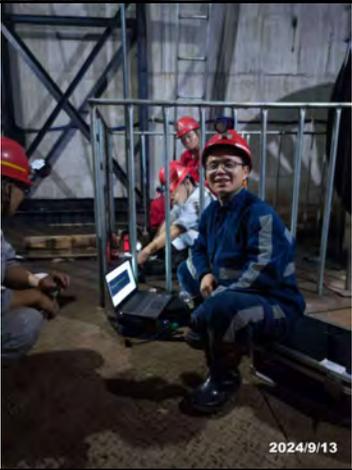
<p>2024/9/13</p>
154	GX-B1598/24-2-24207	2024. 9. 25	实测钢丝绳有效截面积 损失百分比最大为 1.46%，小于5%为正常 。

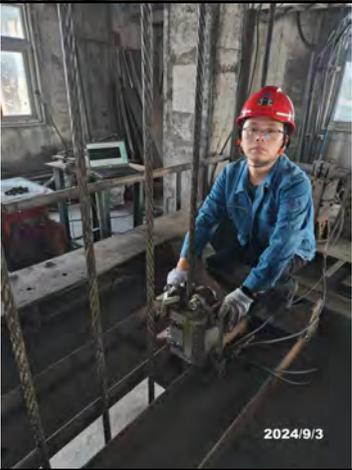
168	GX-B1598/24-2-24177	2024. 9. 25	实测钢丝绳有效截面积 损失百分比最大为 1.48%，小于5%为正常 。

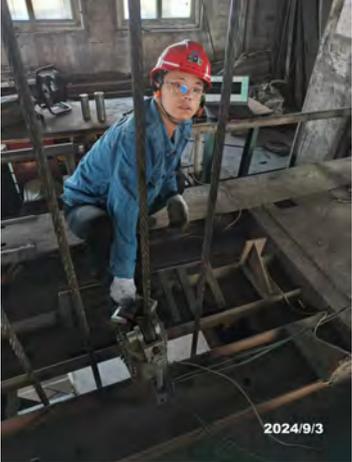
169	GX-B1598/24-2-24178	2024. 9. 25	实测钢丝绳有效截面积 损失百分比最大为 1.77%，小于5%为正常 。

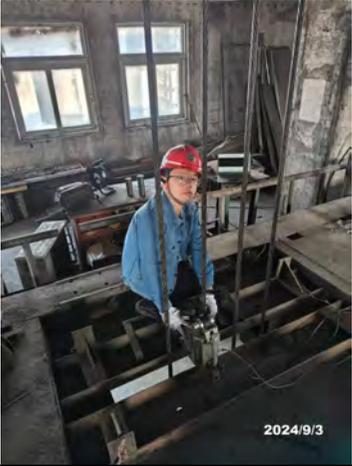
170	GX-B1598/24-2-24179	2024. 9. 25	实测钢丝绳有效截面积 损失百分比最大为 1.78%，小于5%为正常 。

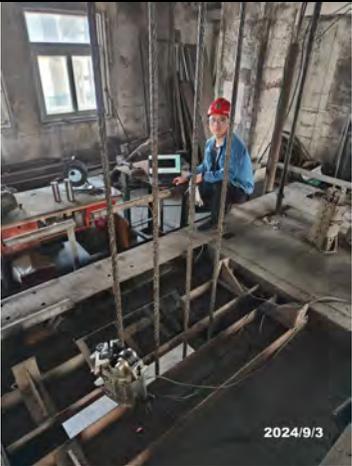
171	GX-B1598/24-2-24180	2024. 9. 25	实测钢丝绳有效截面积 损失百分比最大为 1.60%，小于5%为正常 。

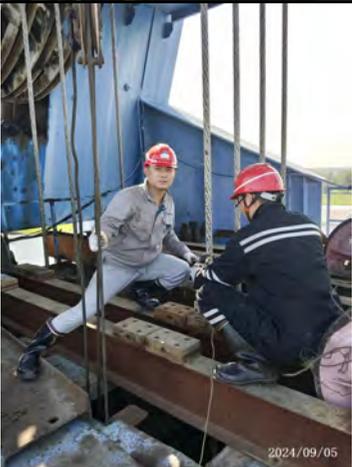
172	GX-B1598/24-2-24181	2024. 9. 25	实测钢丝绳有效截面积 损失百分比最大为 2.15%，小于5%为正常 。

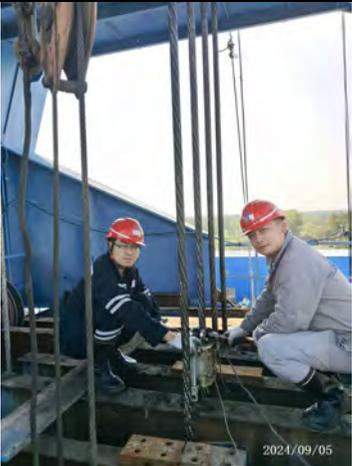
173	GX-B1598/24-2-24182	2024. 9. 25	实测钢丝绳有效截面积 损失百分比最大为 1.92%，小于5%为正常 。

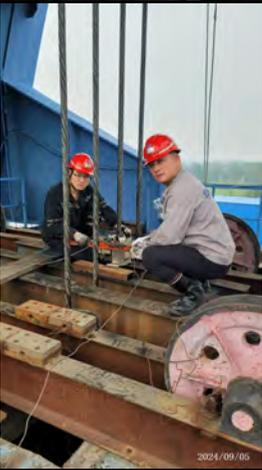
<p>2024/09/05</p>
174	GX-B1598/24-2-24183	2024. 9. 25	实测钢丝绳有效截面积 损失百分比最大为 2.24%，小于5%为正常 。

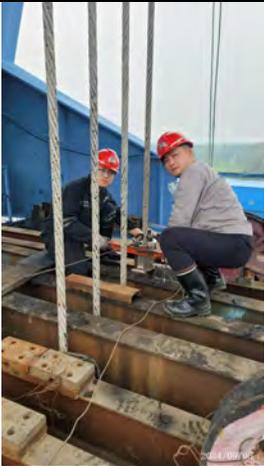
175	GX-B1598/24-2-24184	2024. 9. 25	实测钢丝绳有效截面积 损失百分比最大为 1.88%，小于5%为正常 。
