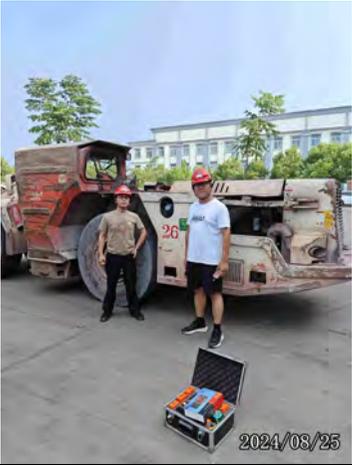
序号	报告编号	发布日期	结论	影像资料
113	GX-B1534/20-2-24036	2024. 9. 23	所检项目合格。

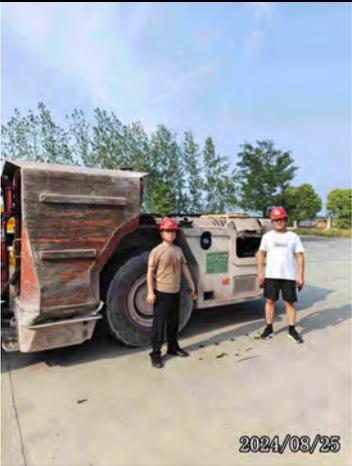
<p>2024/03/25</p>
114	GX-B1534/20-2-24037	2024. 9. 23	所检项目合格。

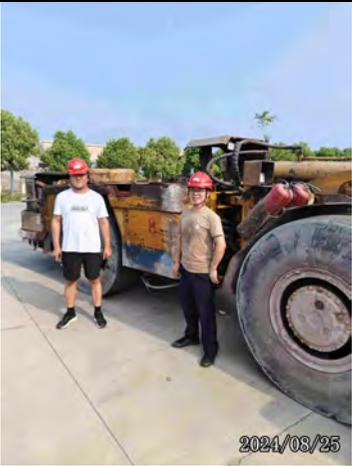
115	GX-B1534/20-2-24038	2024. 9. 23	所检项目合格。

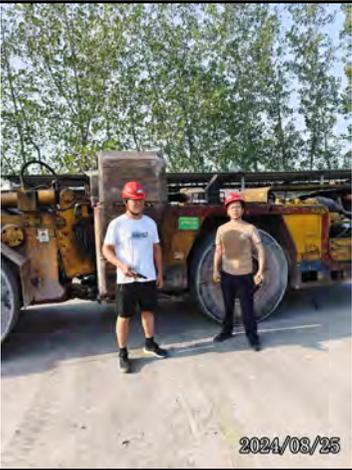
<p>2024/03/25</p>
116	GX-B1534/20-2-24039	2024. 9. 23	所检项目合格。

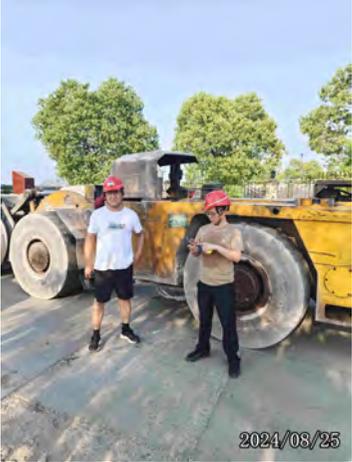
117	GX-B1534/20-2-24040	2024. 9. 23	所检项目合格。

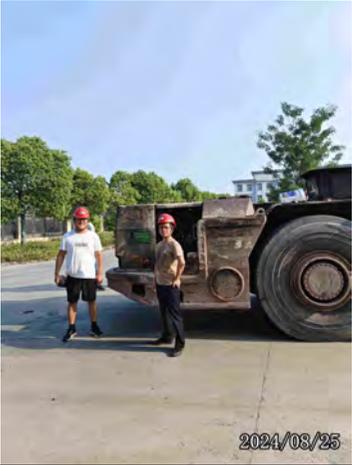
<p>2024/03/25</p>
118	GX-B1534/20-2-24041	2024. 9. 23	所检项目合格。

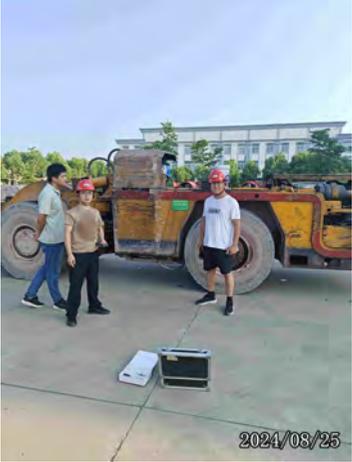
119	GX-B1534/20-2-24042	2024. 9. 23	所检项目合格。

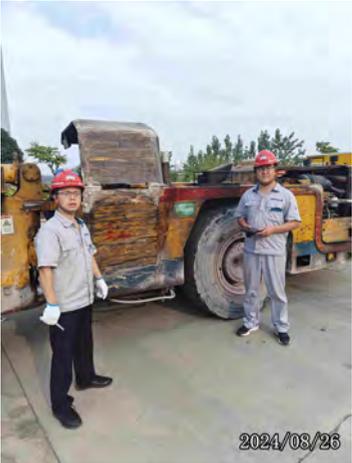
120	GX-B1534/20-2-24043	2024. 9. 23	所检项目合格。

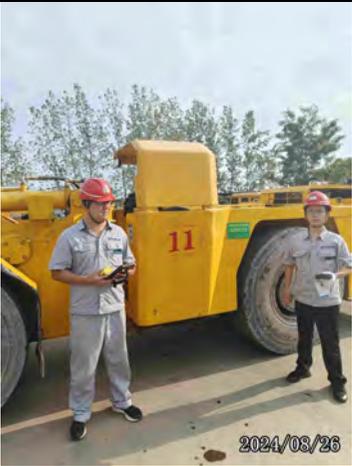
121	GX-B1534/20-2-24044	2024. 9. 23	所检项目合格。

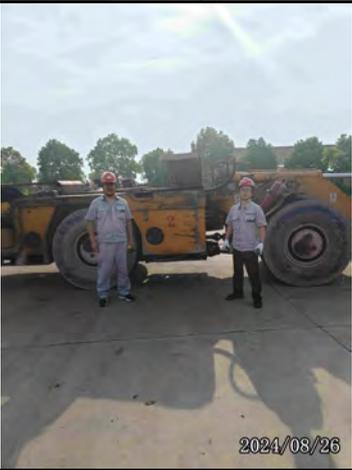
122	GX-B1534/20-2-24045	2024. 9. 23	所检项目合格。

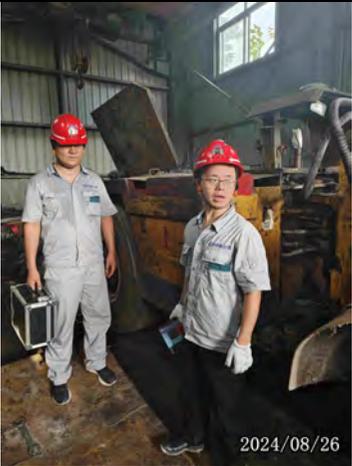
123	GX-B1534/20-2-24046	2024. 9. 23	所检项目合格。

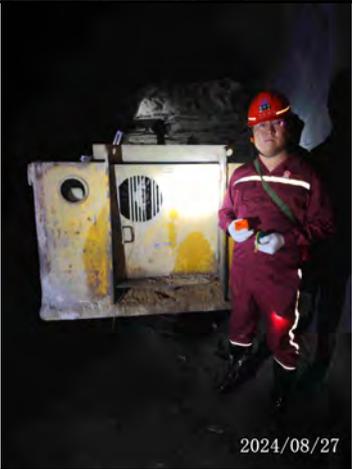
124	GX-B1534/20-2-24047	2024. 9. 23	所检项目合格。

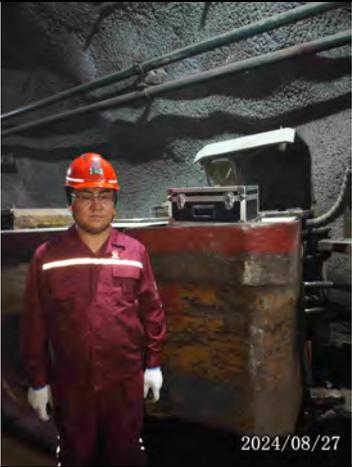
125	GX-B1534/20-2-24048	2024. 9. 23	所检项目合格。

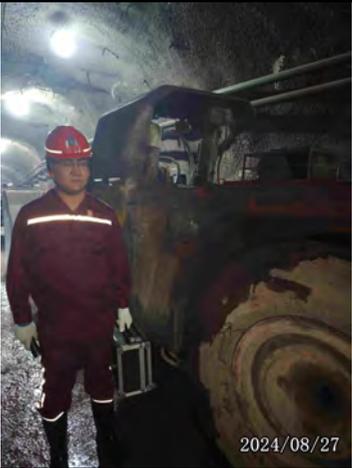
126	GX-B1534/20-2-24049	2024. 9. 23	所检项目合格。

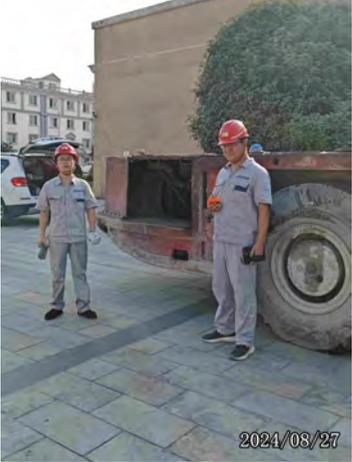
127	GX-B1534/20-2-24050	2024. 9. 23	所检项目合格。

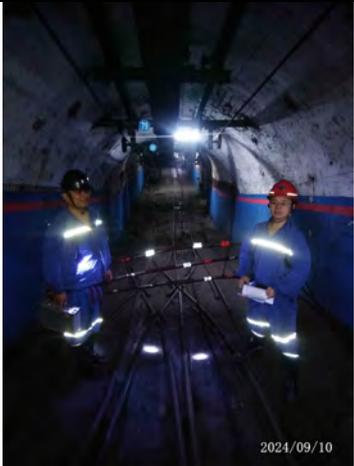
145	GX-B1418/23-2-24017	2024. 9. 20	综合判定：合格。

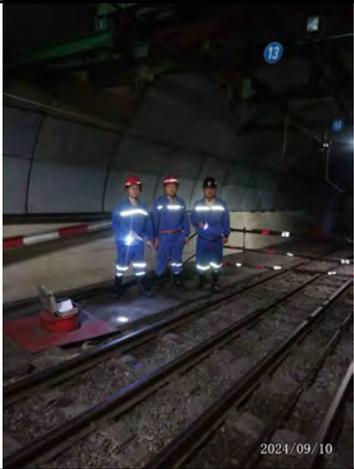
146	GX-B1418/23-2-24018	2024. 9. 20	综合判定：合格。

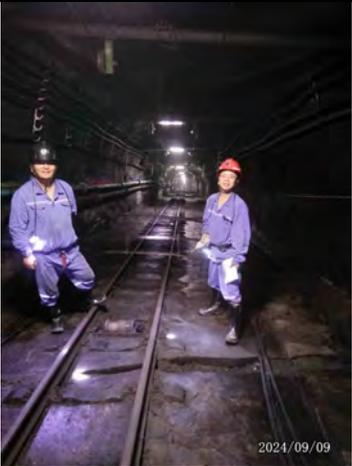
147	GX-B1418/23-2-24019	2024. 9. 20	综合判定：合格。

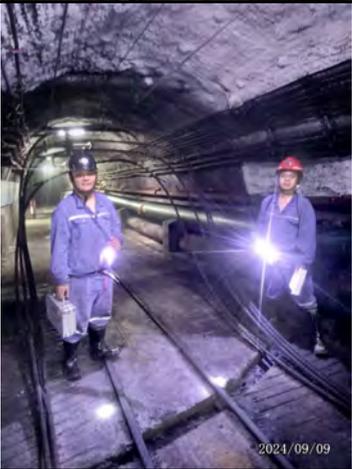
148	GX-B1418/23-2-24020	2024. 9. 20	综合判定：合格。

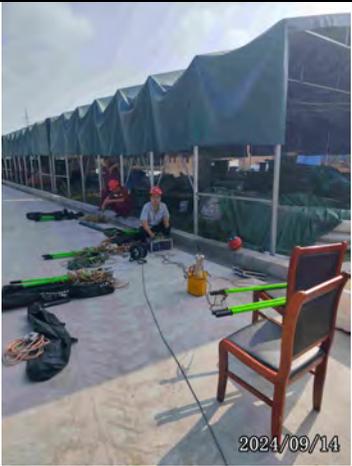
149	GX-B1328/20-2-24088	2024. 9. 26	所检项目合格。

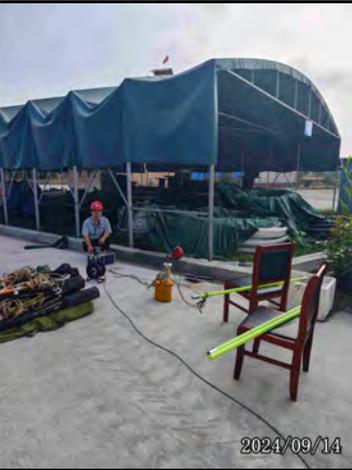
150	GX-B1328/20-2-24089	2024. 9. 26	所检项目合格。

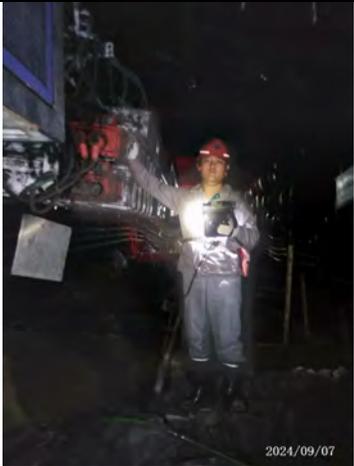
155	GX-B1310/21-2-24319	2024. 9. 20	符合标准要求。

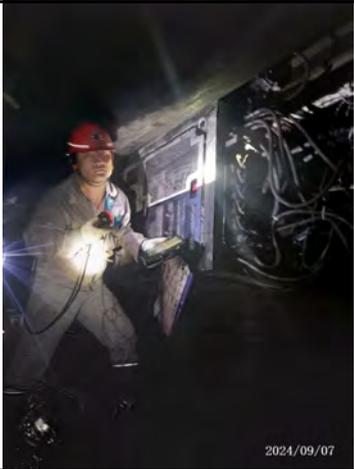
<p>2024/09/07</p>	
156	GX-B1310/21-2-24320	2024. 9. 20	符合标准要求。

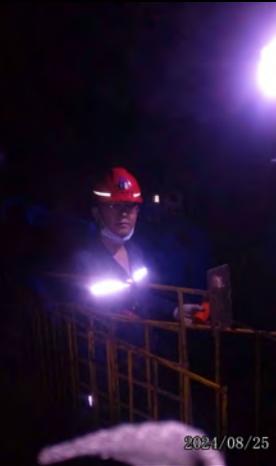
157	GX-B1515/22-2-24012	2024. 9. 26	滚筒绳衬直径与钢丝绳直径之比小于50倍。 除上述问题外，其余所检项目合格。

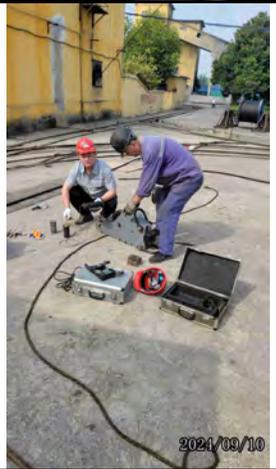
158	GX-B1310/21-2-24322	2024. 9. 20	符合标准要求。

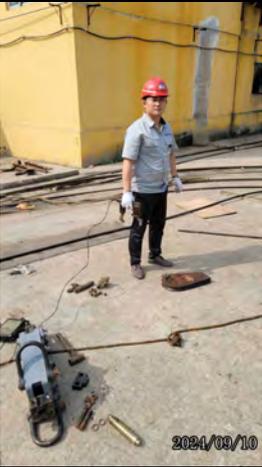
159	GX-B1427/21-2-24322	2024. 9. 20	符合标准要求。

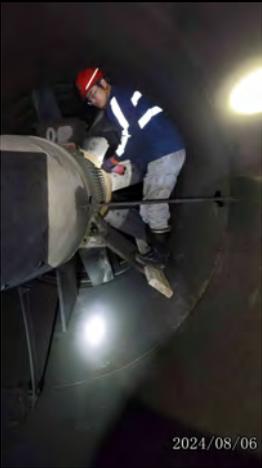
<p>2024/09/10</p>
160	GX-B1428/21-2-24337	2024. 9. 25	无缺陷迹痕显示。

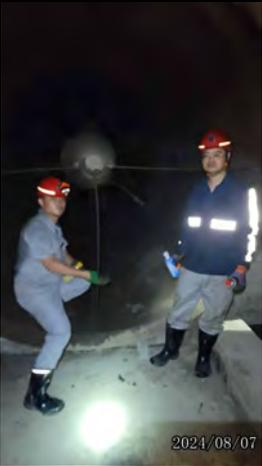
161	GX-B1428/21-2-24338	2024. 9. 25	无缺陷迹痕显示。

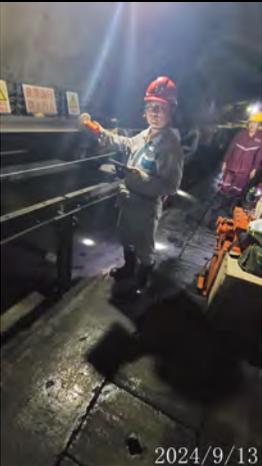
163	GX-B1416/22-2-24026	2024. 9. 25	综合判定：合格。

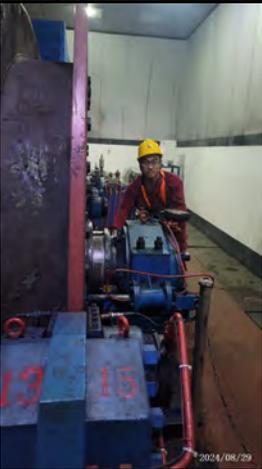
164	GX-B1310/21-2-24308	2024. 9. 25	符合标准要求。

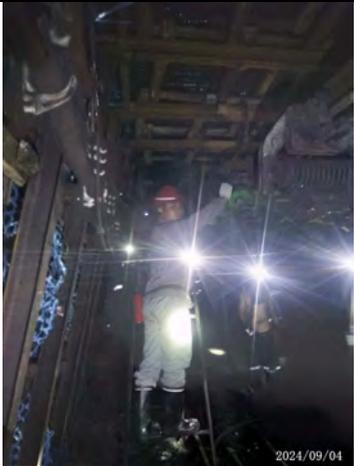
165	GX-B1310/21-2-24315	2024. 9. 20	符合标准要求。

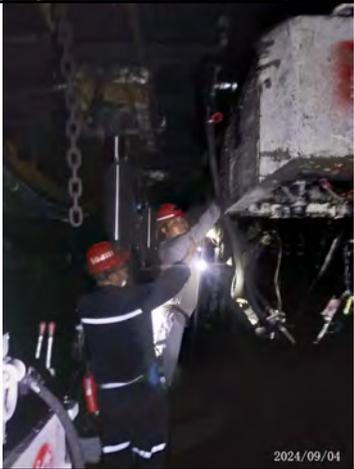
166	GX-B1310/21-2-24316	2024. 9. 20	符合标准要求。

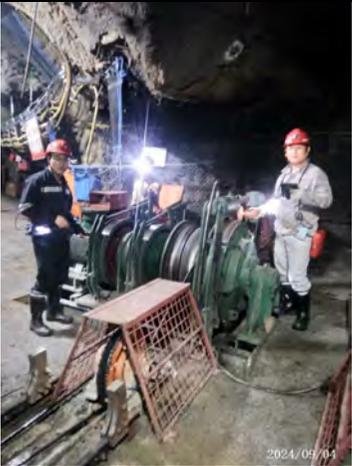
167	GX-B1515/22-2-24011	2024. 9. 22	所检项目合格。

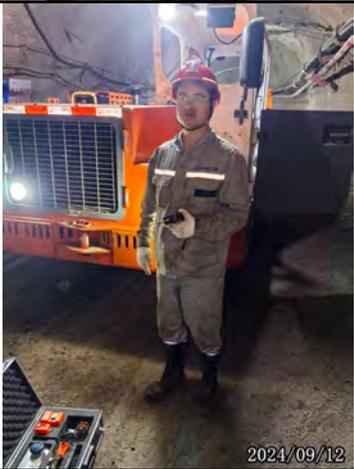
176	GX-B1534/20-2-24124	2024. 9. 26	所检项目合格。

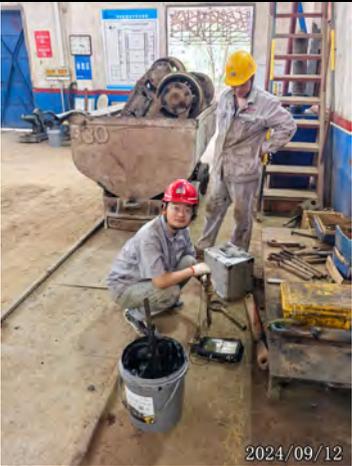
177	GX-B1310/21-2-24336	2024. 9. 26	符合标准要求。

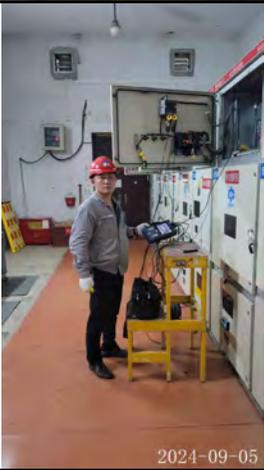
<p>2024/09/12</p>
178	GX-B1404/20-2-24029	2024. 9. 25	所检电网谐波电压总谐波畸变率、各次谐波电压含有率、谐波电流符合 GB/T 14549-1993 《电能质量 公用电网谐波》要求。

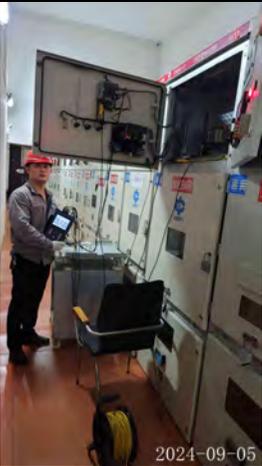
179	GX-B1404/20-2-24030	2024. 9. 25	所检电网谐波电压总谐波畸变率、各次谐波电压含有率、谐波电流符合 GB/T 14549-1993 《电能质量 公用电网谐波》要求。

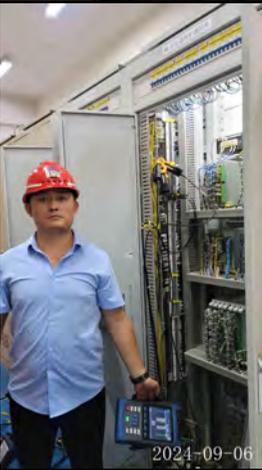
180	GX-B1404/20-2-24031	2024. 9. 25	所检电网谐波电压总谐波畸变率、各次谐波电压含有率、谐波电流符合 GB/T 14549-1993 《电能质量 公用电网谐波》要求。

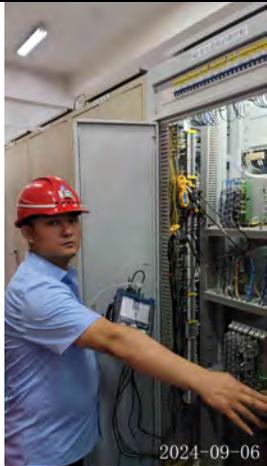
181	GX-B1404/20-2-24032	2024. 9. 25	所检电网谐波电压总谐波畸变率、各次谐波电压含有率、谐波电流符合 GB/T 14549-1993 《电能质量 公用电网谐波》要求。

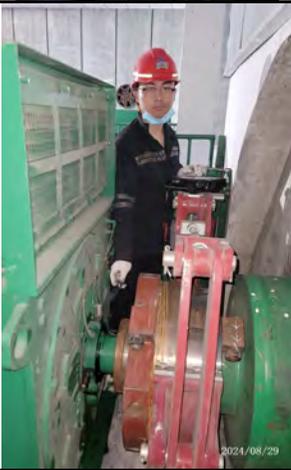
<p>2024-09-06</p>
182	GX-B1310/21-2-24309	2024/9/25	符合标准要求。

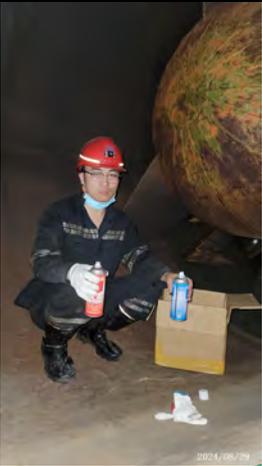
183	GX-B1428/21-2-24309	2024/9/25	无缺陷迹痕显示。

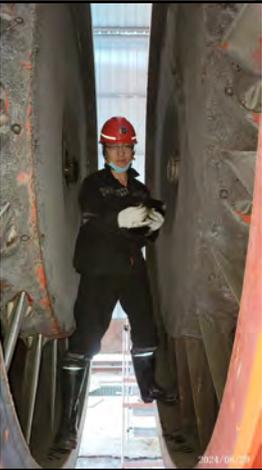
184	GX-B1310/21-2-24310	2024/9/25	符合标准要求。

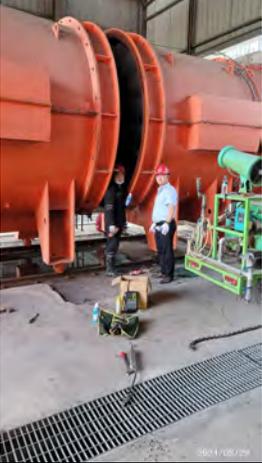
185	GX-B1428/21-2-24310	2024/9/25	无缺陷迹痕显示。

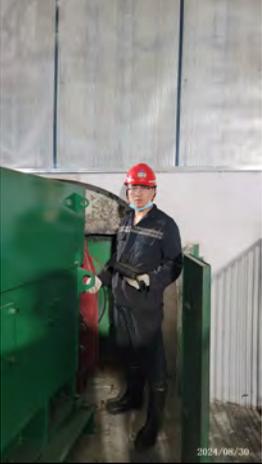
186	GX-B1310/21-2-24311	2024/9/25	符合标准要求。

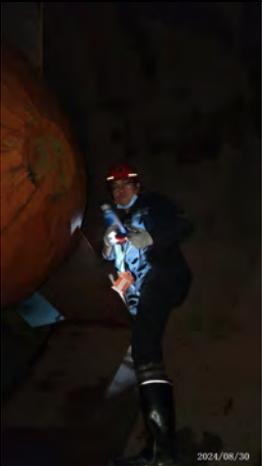
187	GX-B1428/21-2-24311	2024/9/25	无缺陷迹痕显示。

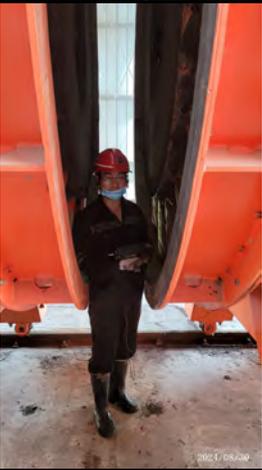
A worker wearing a red hard hat and a blue safety vest is inspecting a large, orange, spherical object in a dark environment. The worker is holding a flashlight, and the scene is dimly lit. A timestamp '2024/08/30' is visible in the bottom right corner of the image.
188	GX-B1310/21-2-24312	2024/9/25	符合标准要求。

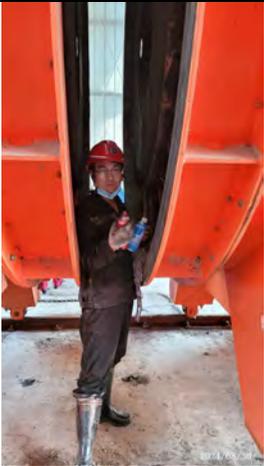
189	GX-B1428/21-2-24312	2024/9/25	无缺陷迹痕显示。

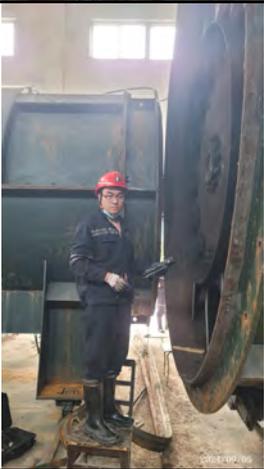
190	GX-B1310/21-2-24317	2024/9/25	符合标准要求。

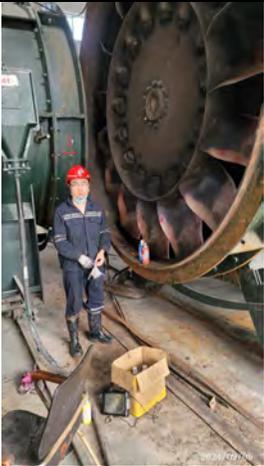
191	GX-B1428/21-2-24317	2024/9/25	无缺陷迹痕显示。

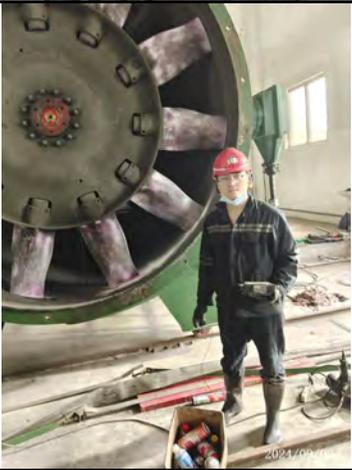
192	GX-B1310/21-2-24318	2024/9/25	符合标准要求。

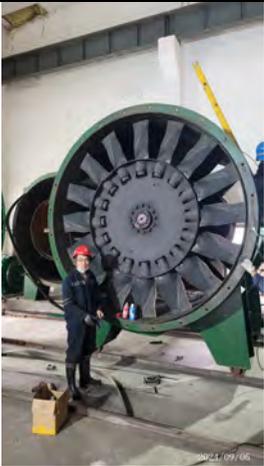
193	GX-B1428/21-2-24318	2024/9/25	无缺陷迹痕显示。

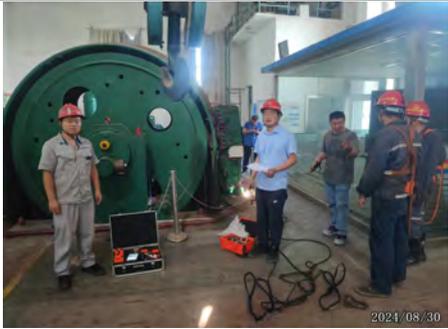
196	GX-B1301/23-2-24008	2024/9/30	综合判定:合格。
